LP-Gas Tank Explosion Kills Two Volunteer Firefighters

Carthage, Illinois

USFA-TR-120/October 1997

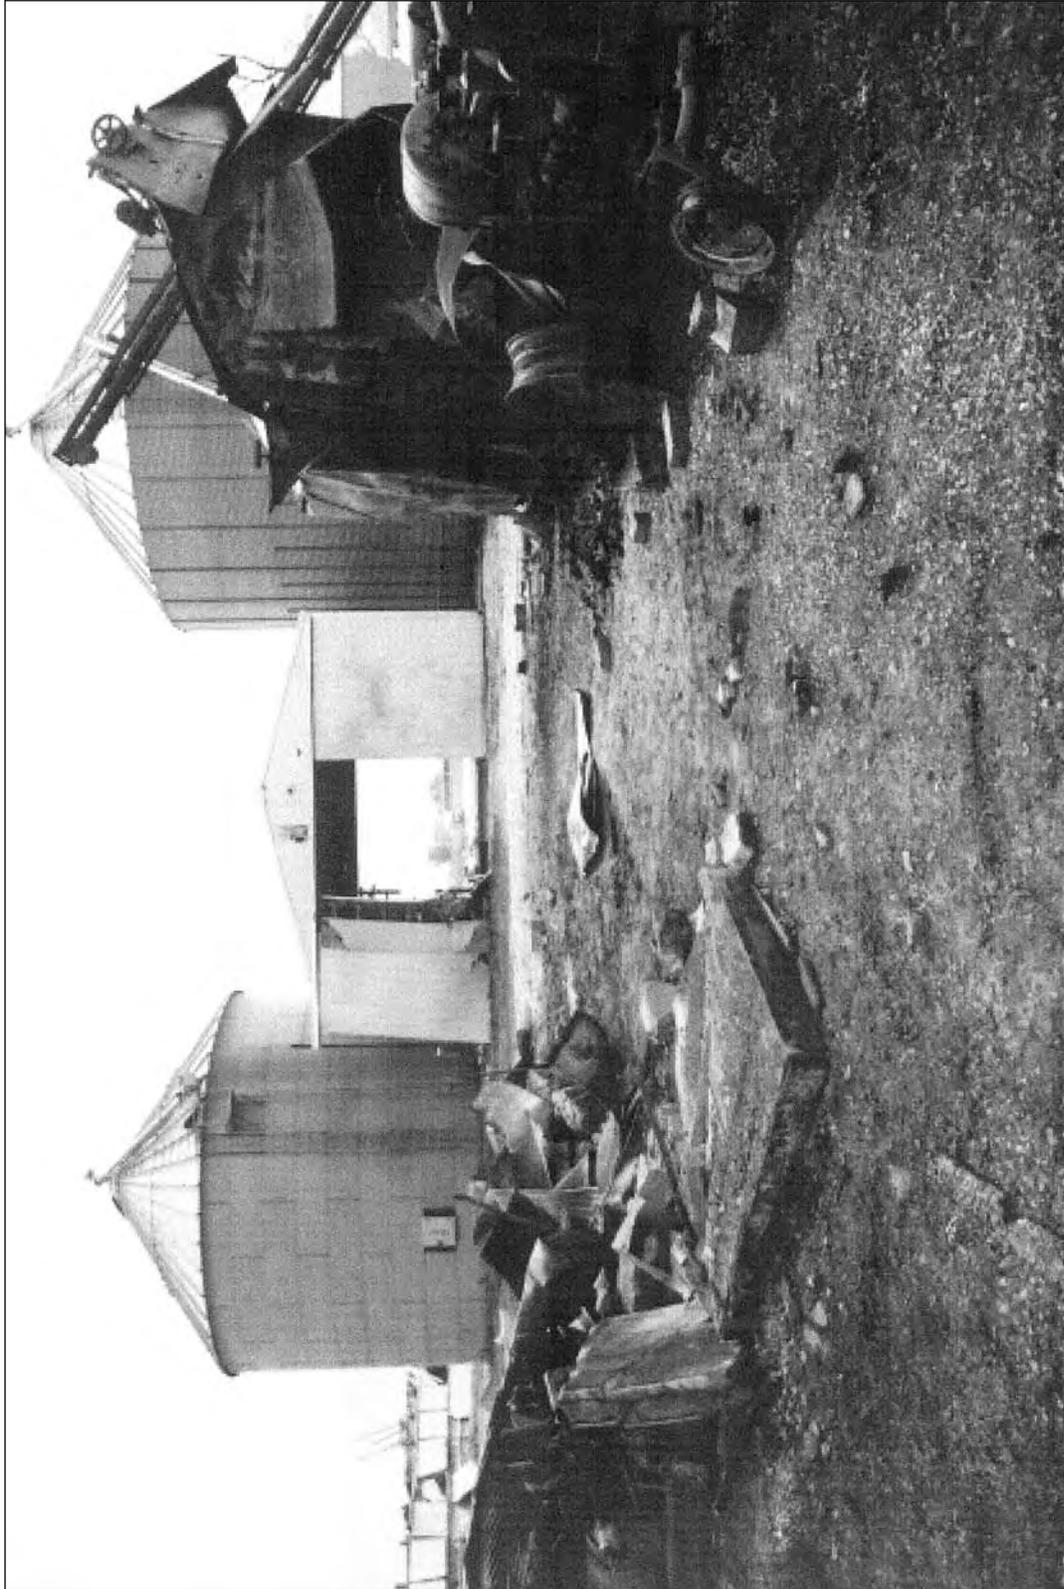
1. Original location of LP-Gas tanks looking south. The grain dryer and LP-Gas fueled tractors are on the right. The tank passed through the pole shed in the center.

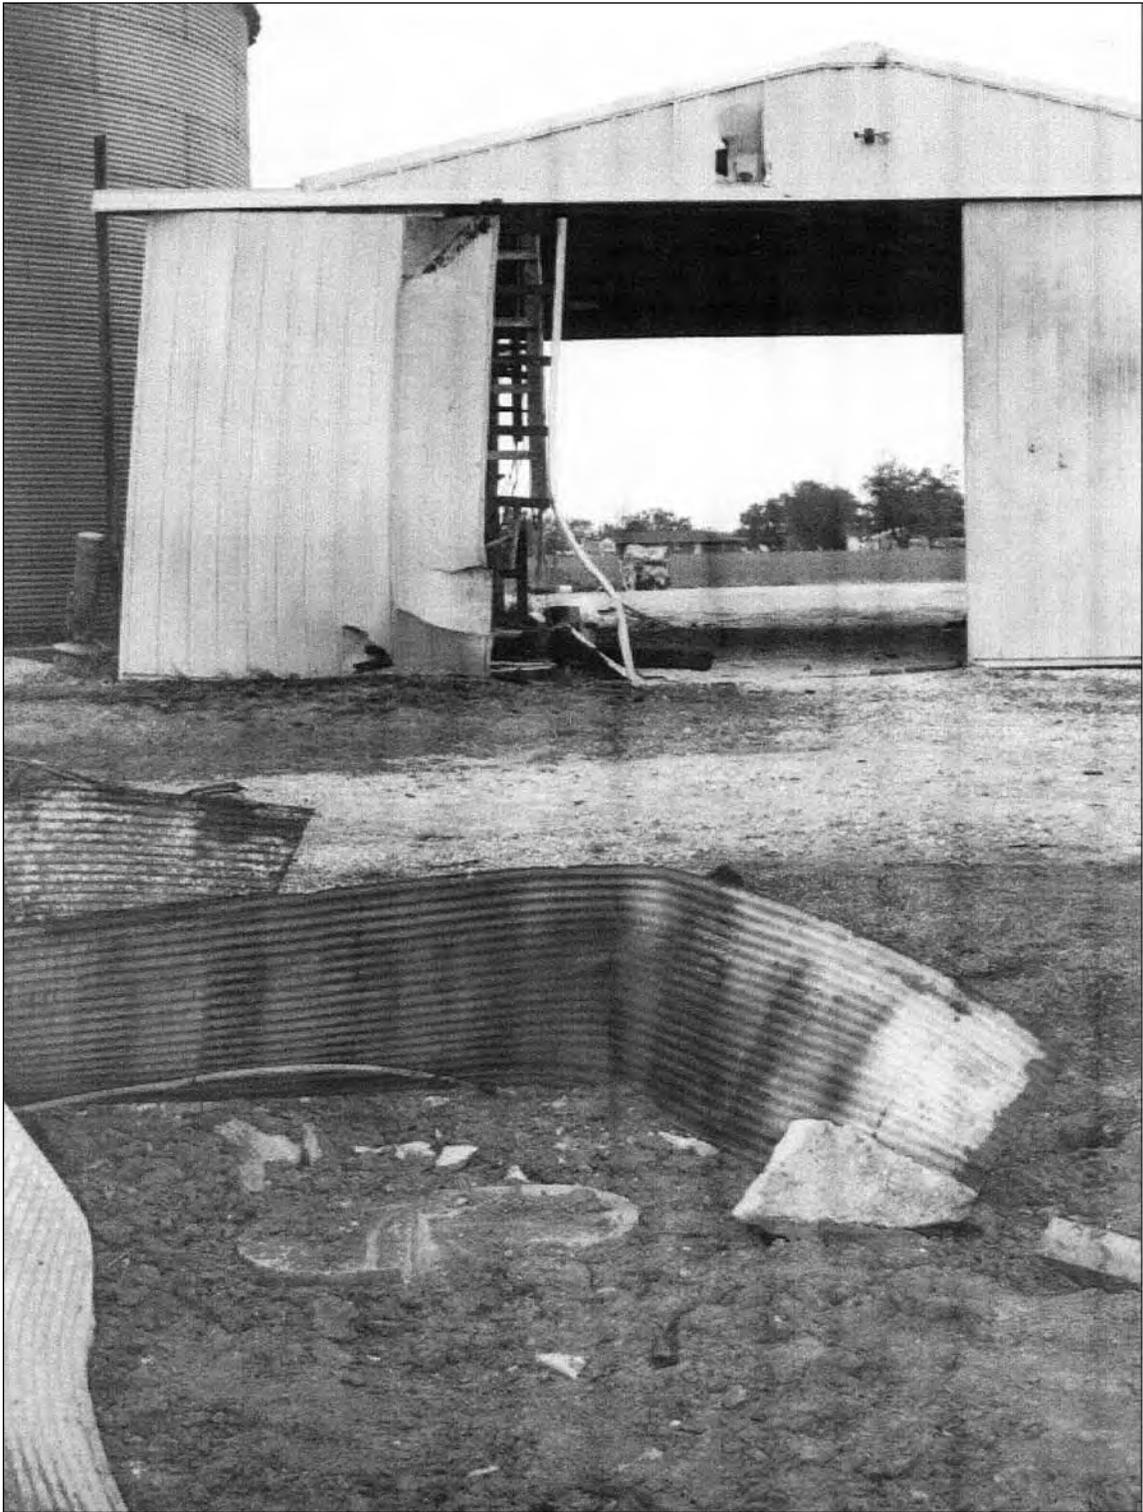
2. Concrete pad for one of the LP-Gas tanks. The pole shed's damaged 6 x 6 wood door posts are in the background. The tank came to a rest near the house in the far background.

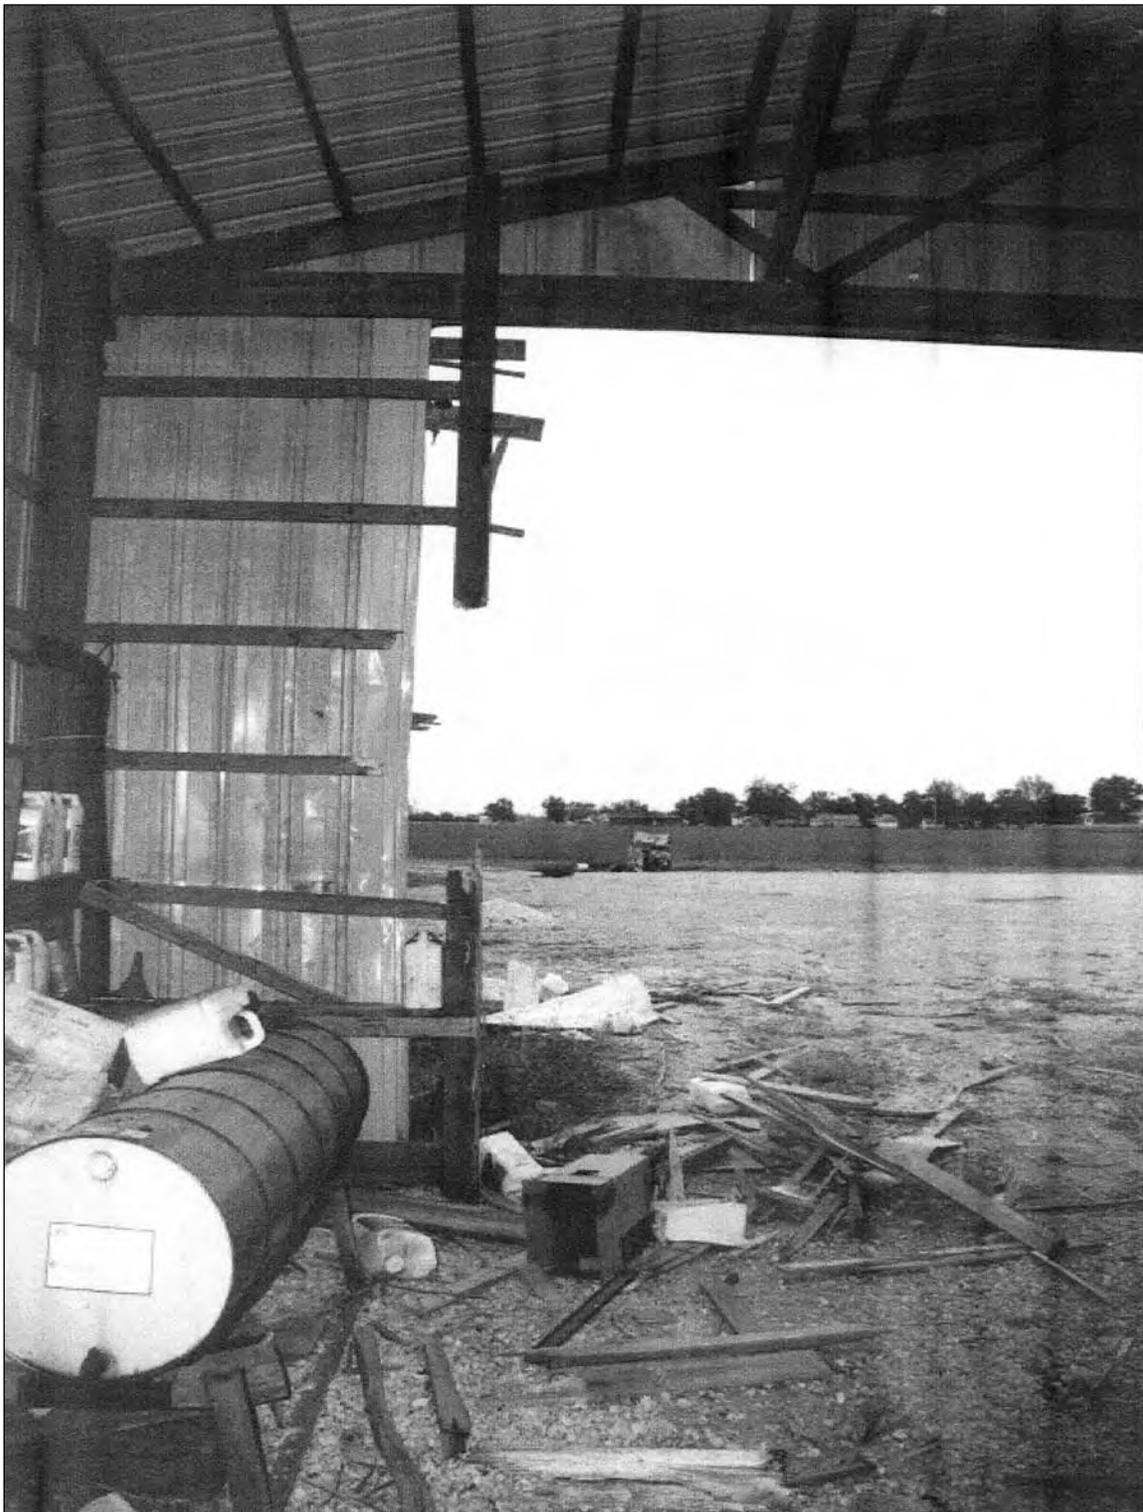
3. Damage to the southeast door post of the pole shed. Three firefighters stood just on the other side.

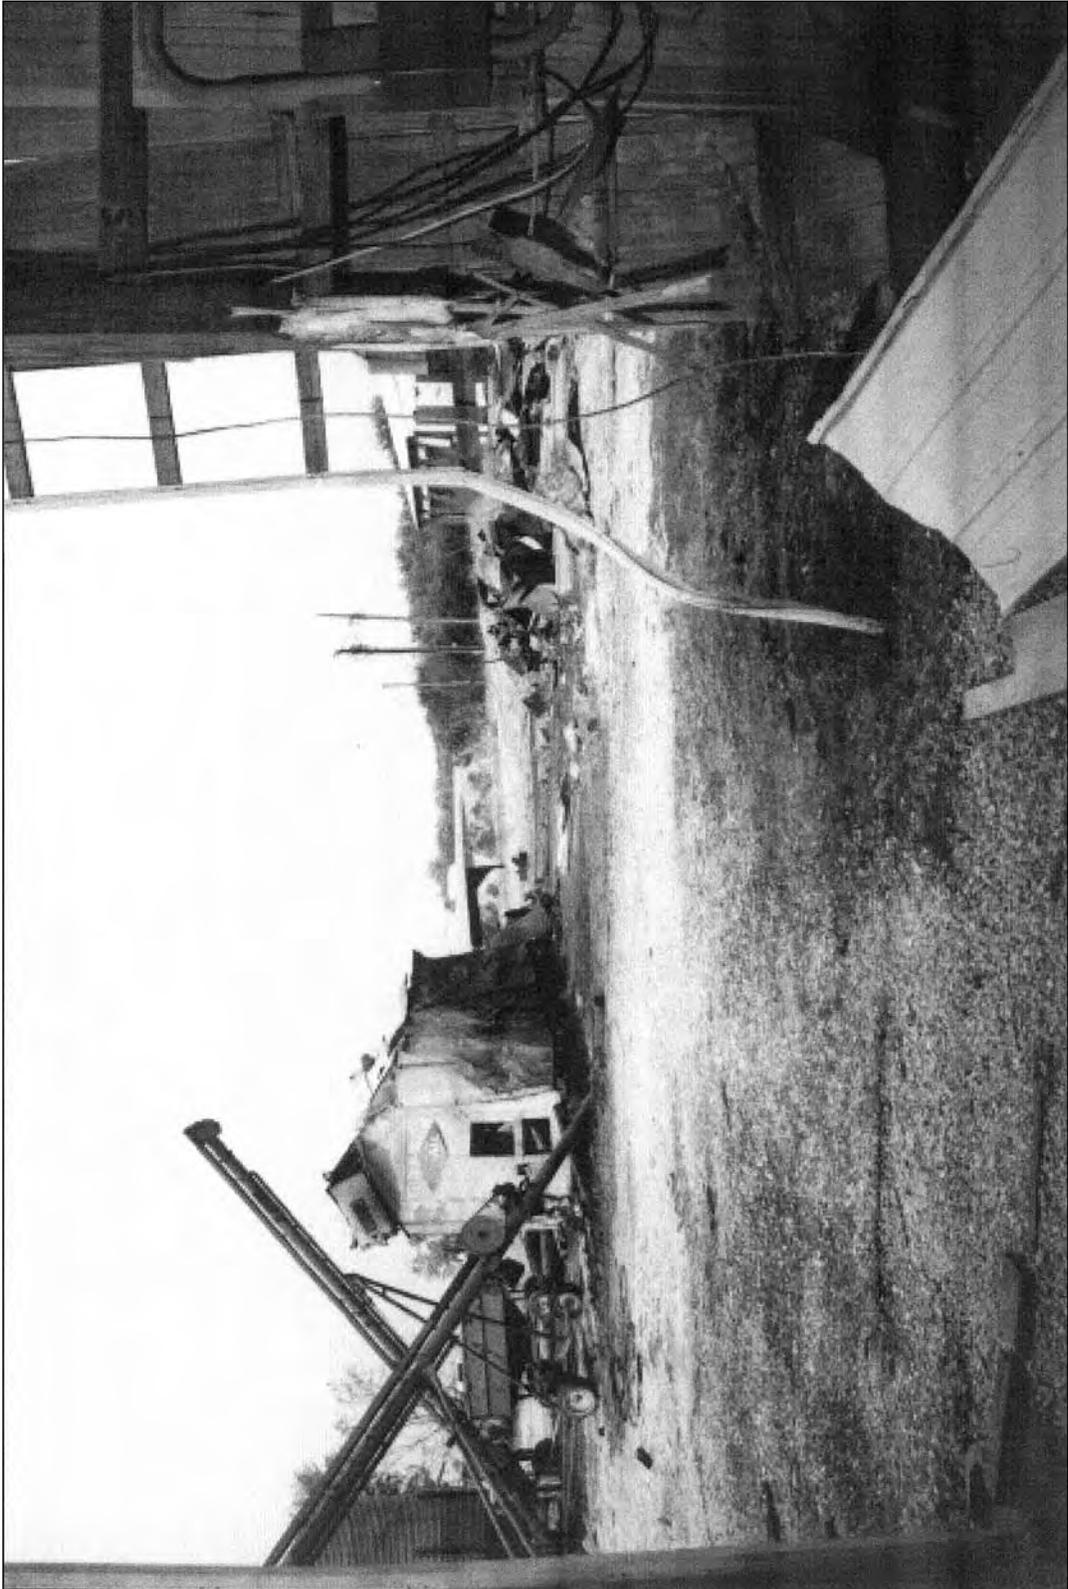
4. Damage to the northeast door post of the pole shed. View of the grain dryer and exposures to the north.

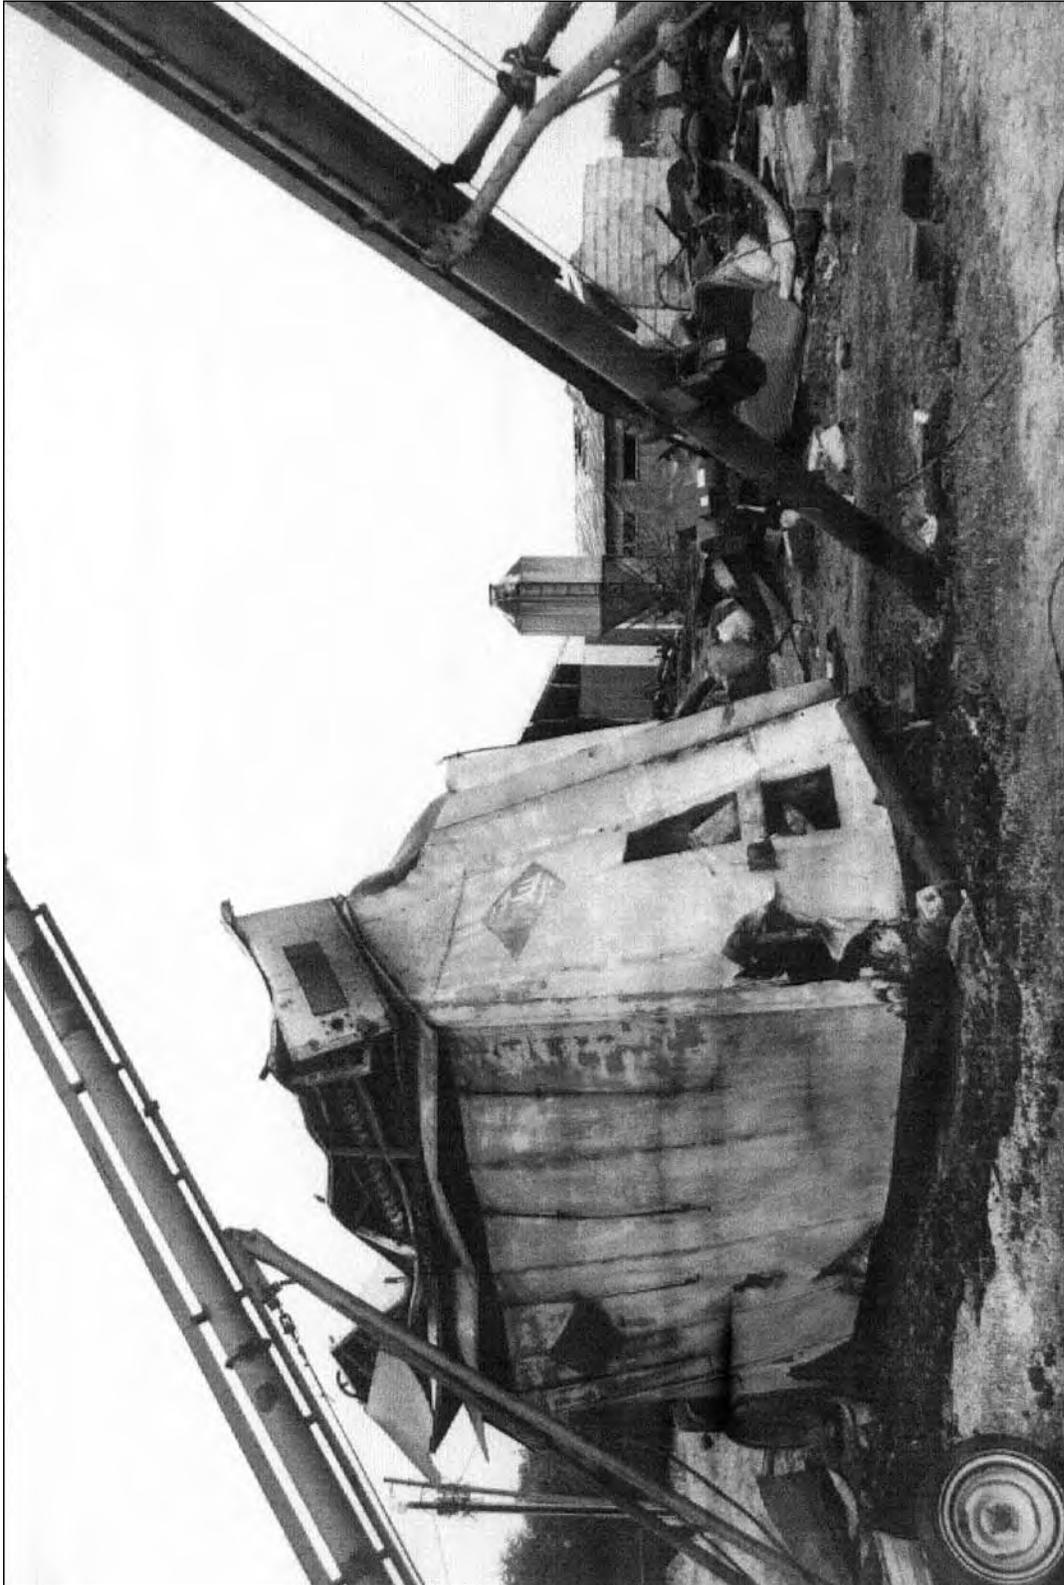
5. The damaged grain dryer and the wood shed to the east. The screw conveyor on the right runs from the dryer's discharge to the grain silo.

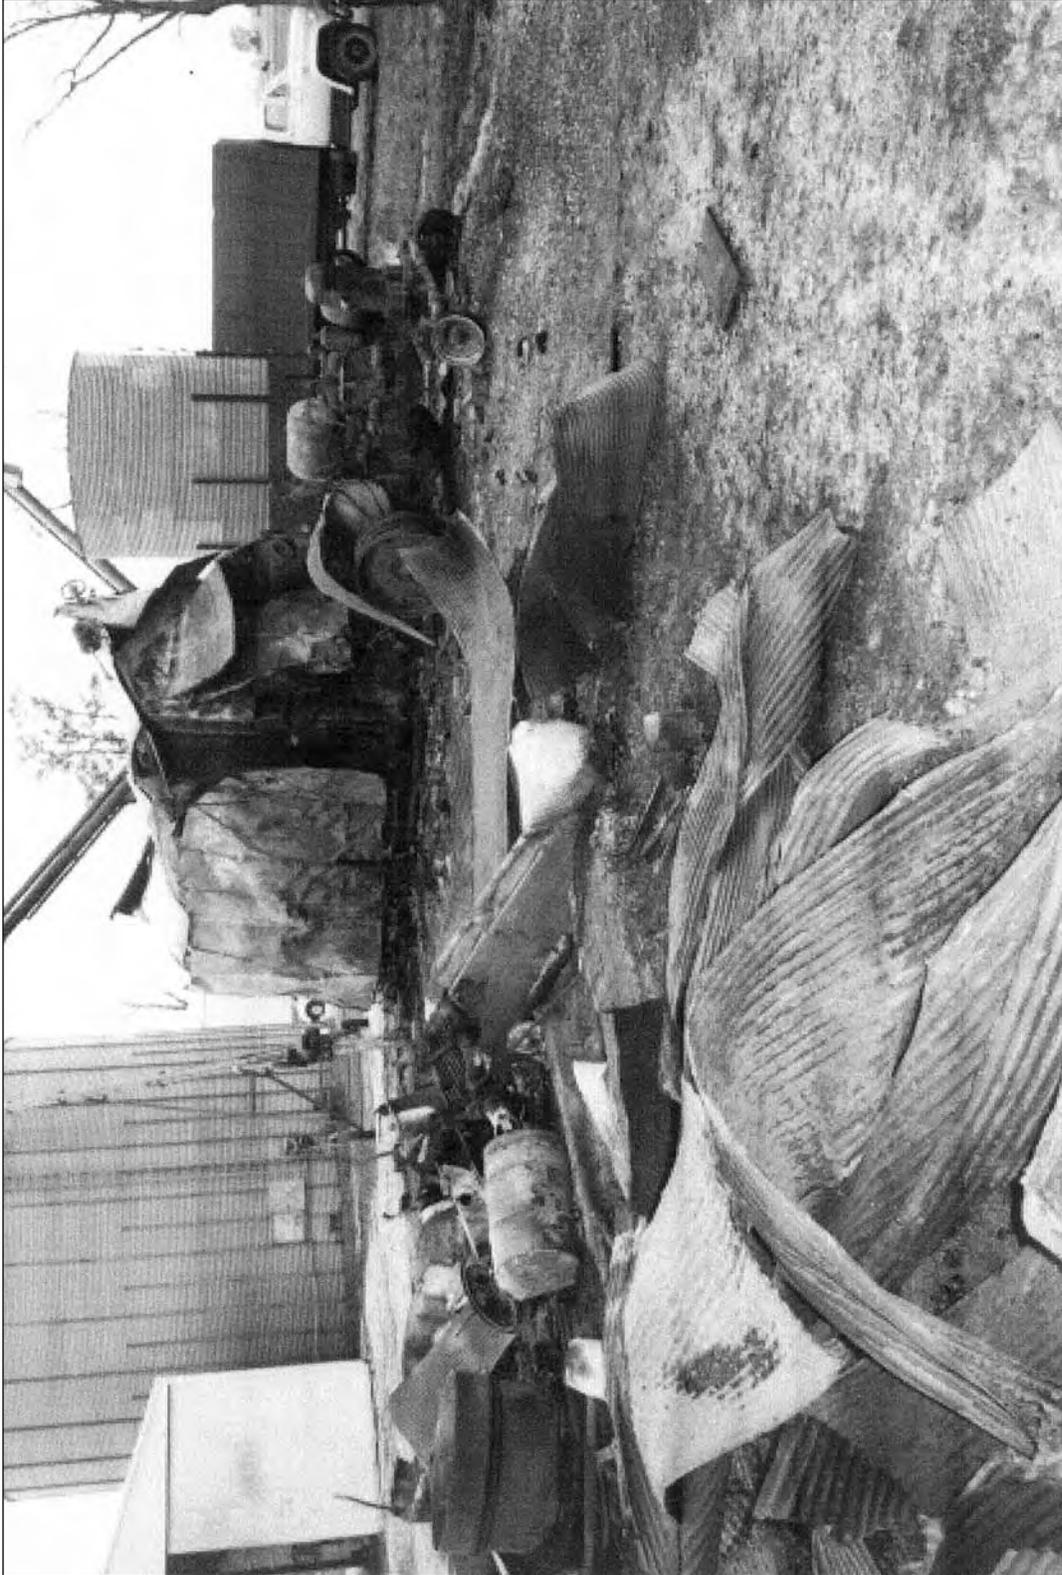
6. Grain dryer, LP-Gas fueled tractor, wet bin, grain silo, and destroyed shed.

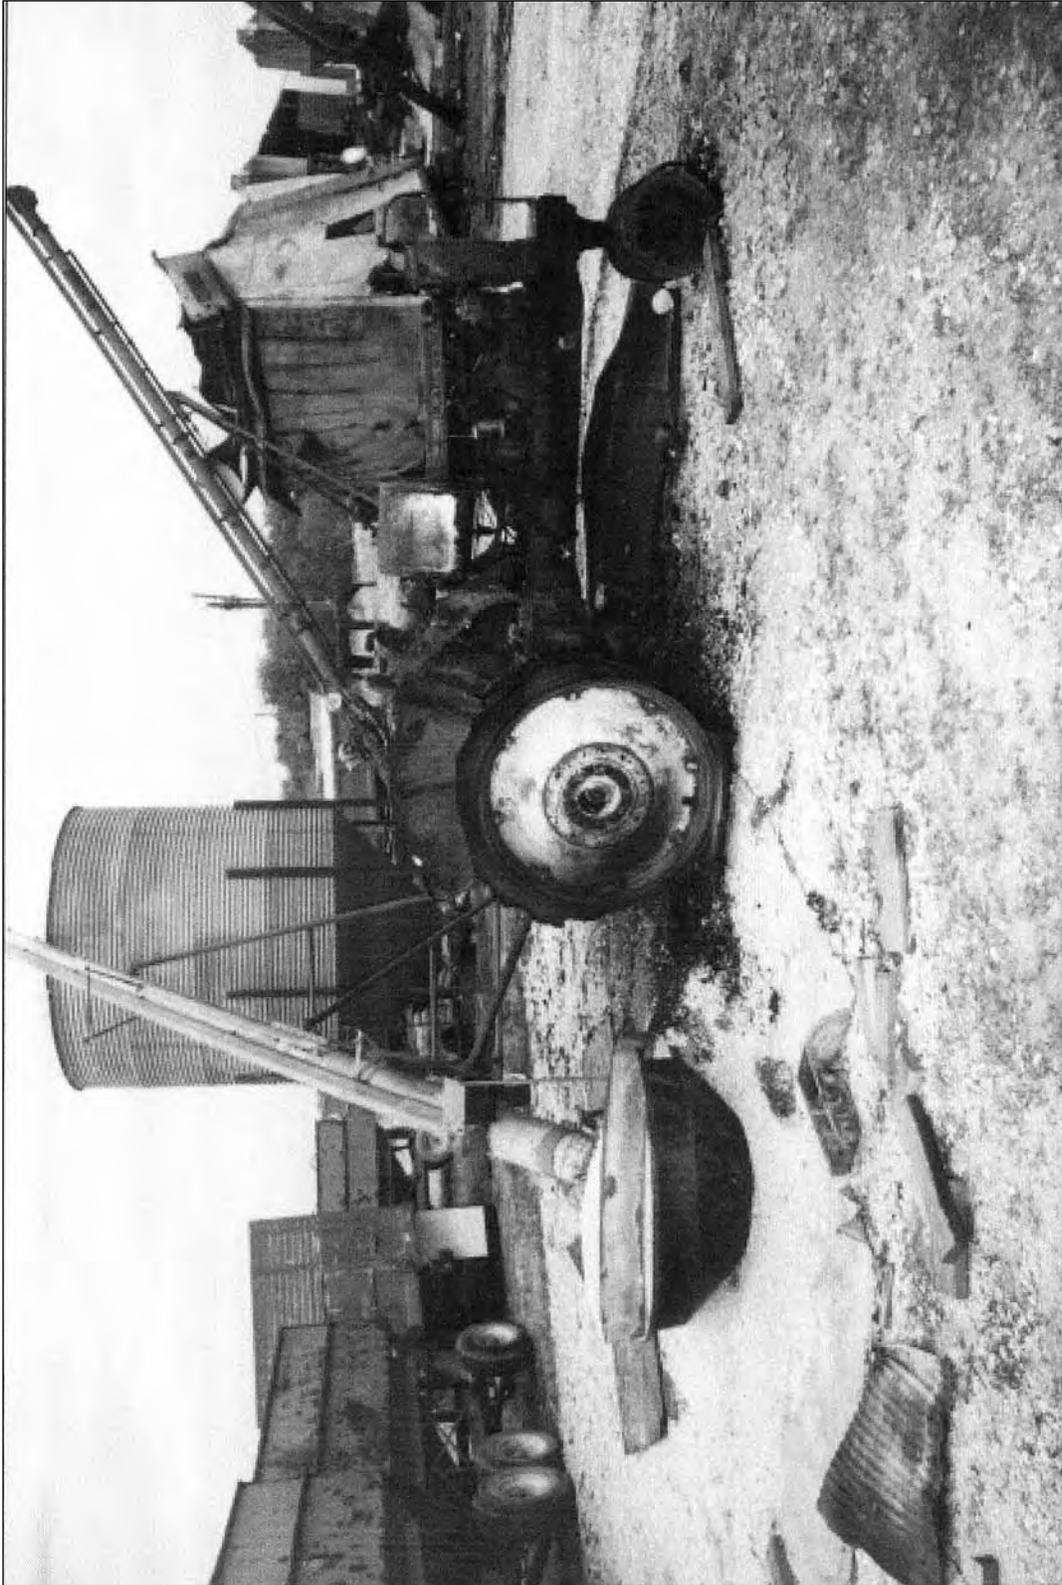
7. Destroyed field tractor that powered the screw conveyor feeding the wet bin. The west LP-Gas tank landed near this tractor on the right side of the photograph.

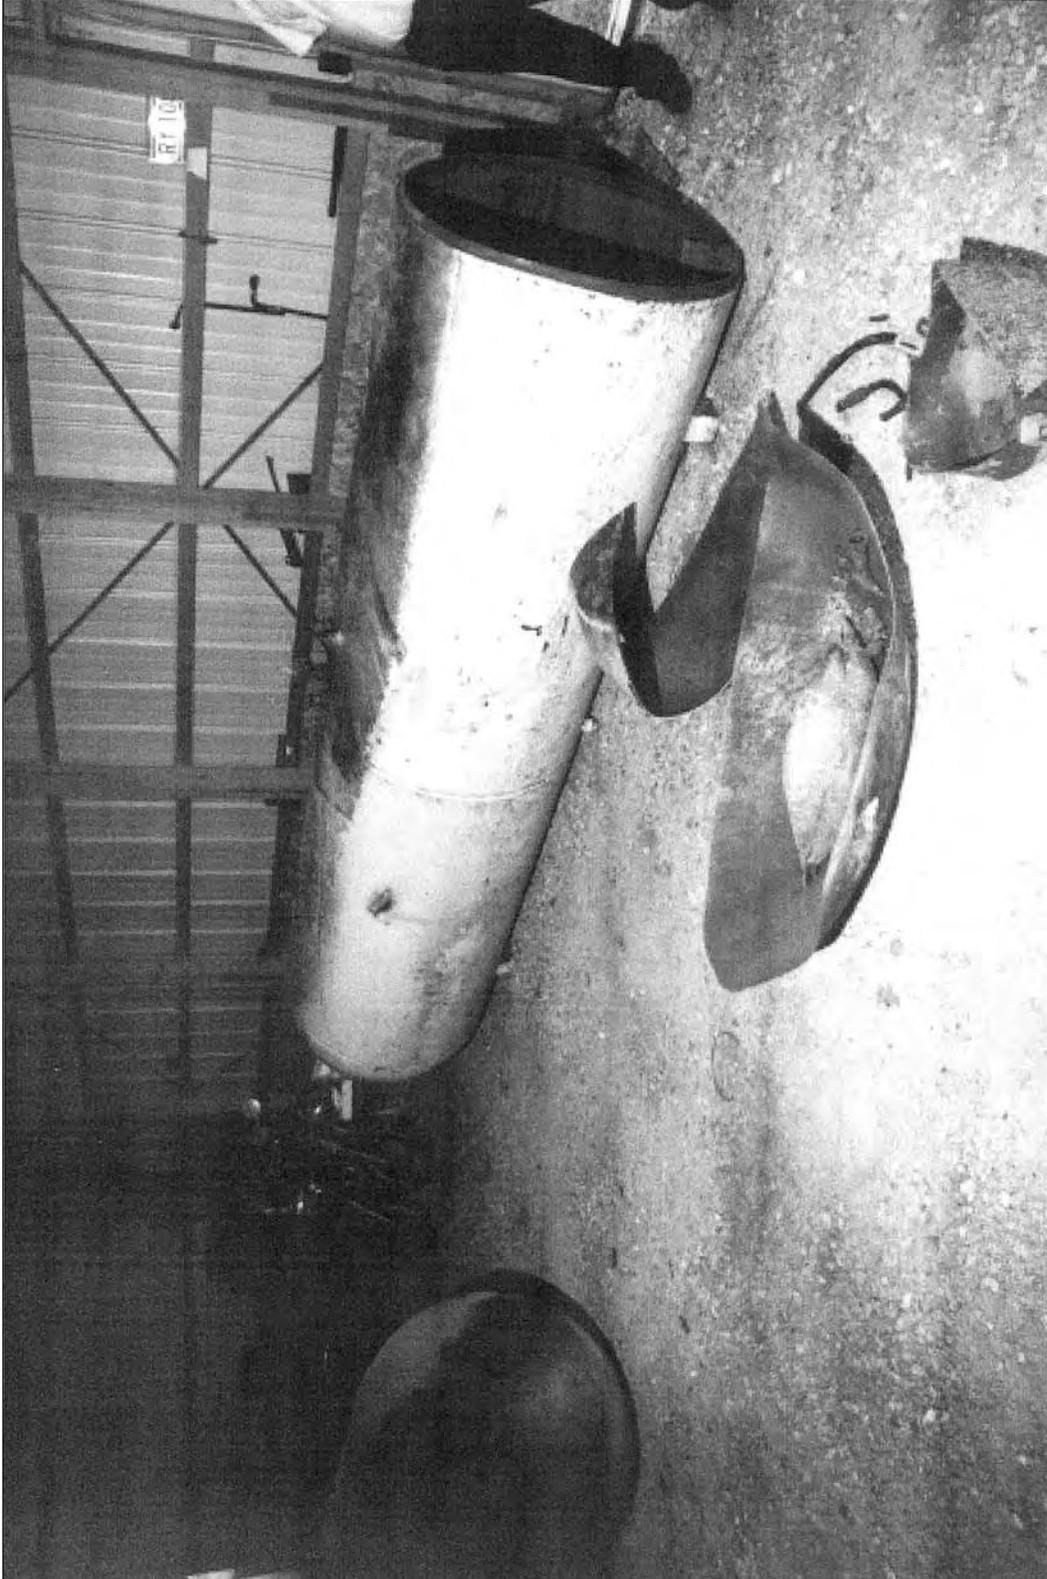
The tank separated at the weld seam where the north domed head was attached to the long cylinder shaped body. The tank head was broken into two pieces ("clam shelled") and the pieces traveled north and northeast into a brush and tree covered ravine area about 600 to 650 feet away. The balance of the tank rocketed to the south in a very shallow climb through the pole shed coming to rest nearly 1,000 feet away. (See Appendix C)

8. The LP-Gas tank that BLEVE'd along with the two parts of the north domed head. The protective valve cover is also in the bottom right corner.

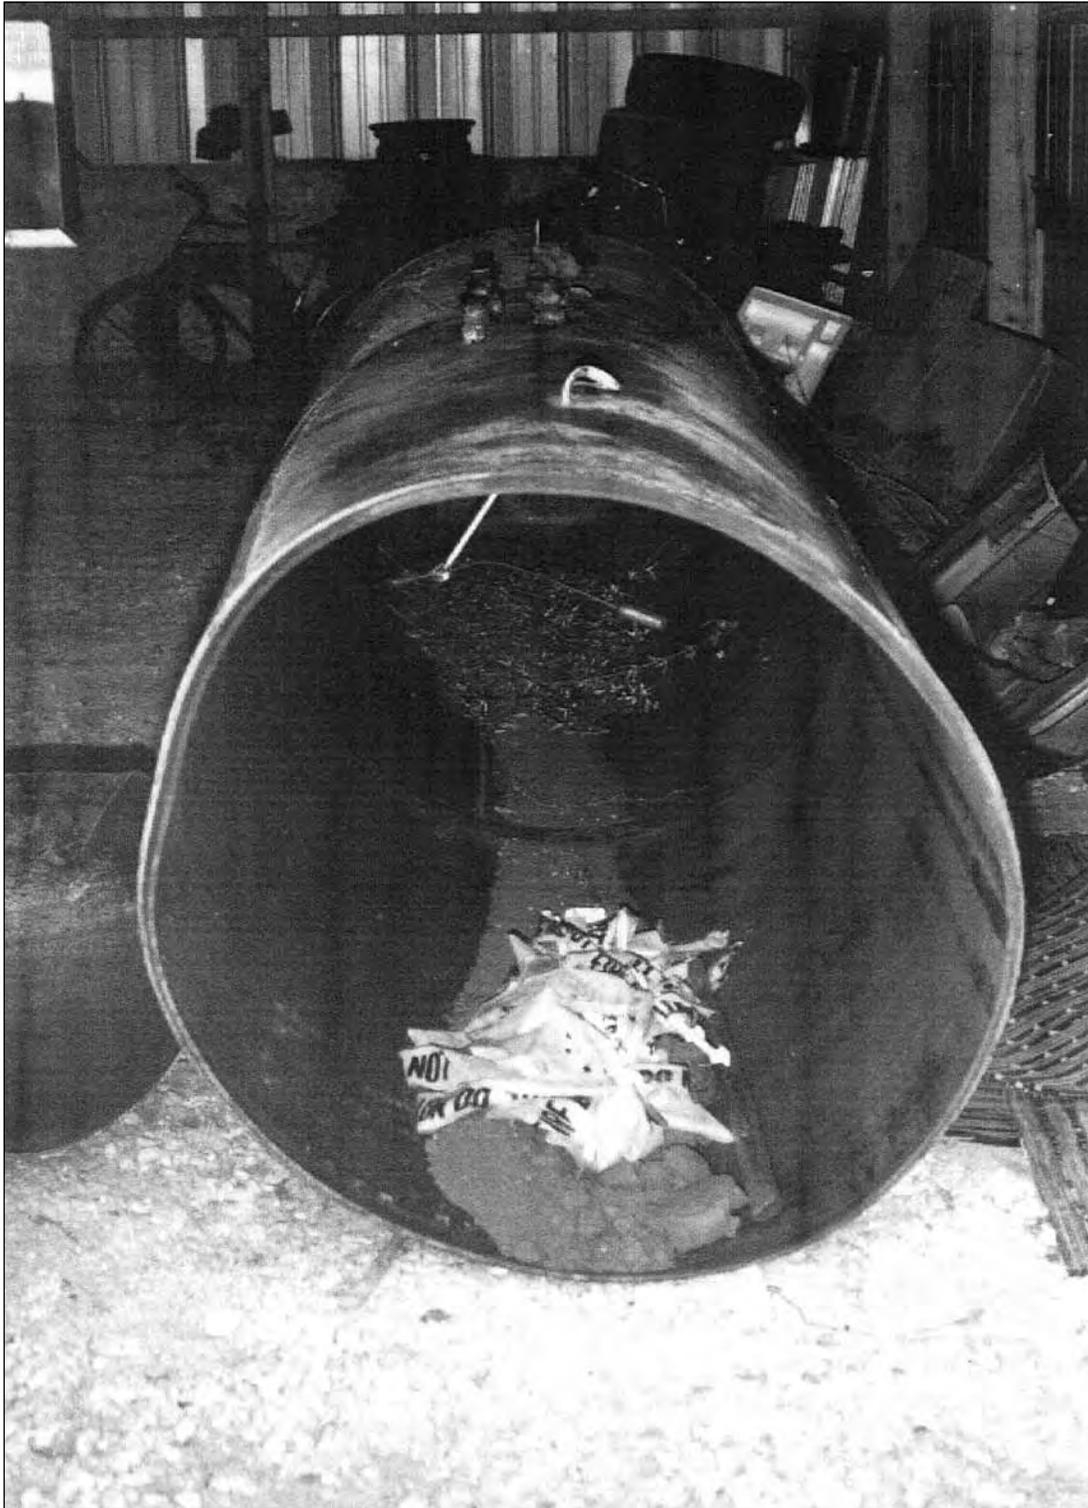
The east LP-Gas tank was moved from the field where it came to rest with a tank carrier. The north head separated from the rest of the tank at the weld seam. The metal at the separation seam (fracture surface) was very smooth on both the tank and on the pieces of the head. The surface was almost like a grinder had passed over it. There were no chevrons¹ on either the tank or the head's fracture surfaces. The paint on the south end of the tank appeared blistered while the paint at the north end was unmarked.

At the time of the scene visit, the roll forming of the metal for the domed head to the tank cylinder weld seam was being reviewed for proper shape. In addition, the position and penetration of the weld bead at this seam was being analyzed. Both were possible contributing causes for the tank failure. Diagrams of the formed metal can be found in Appendix E and photograph of the weld seam in Appendix F.

9. The inside of the BLEVE'd tank and the rolled and welded seam between the cylinder section and the head.

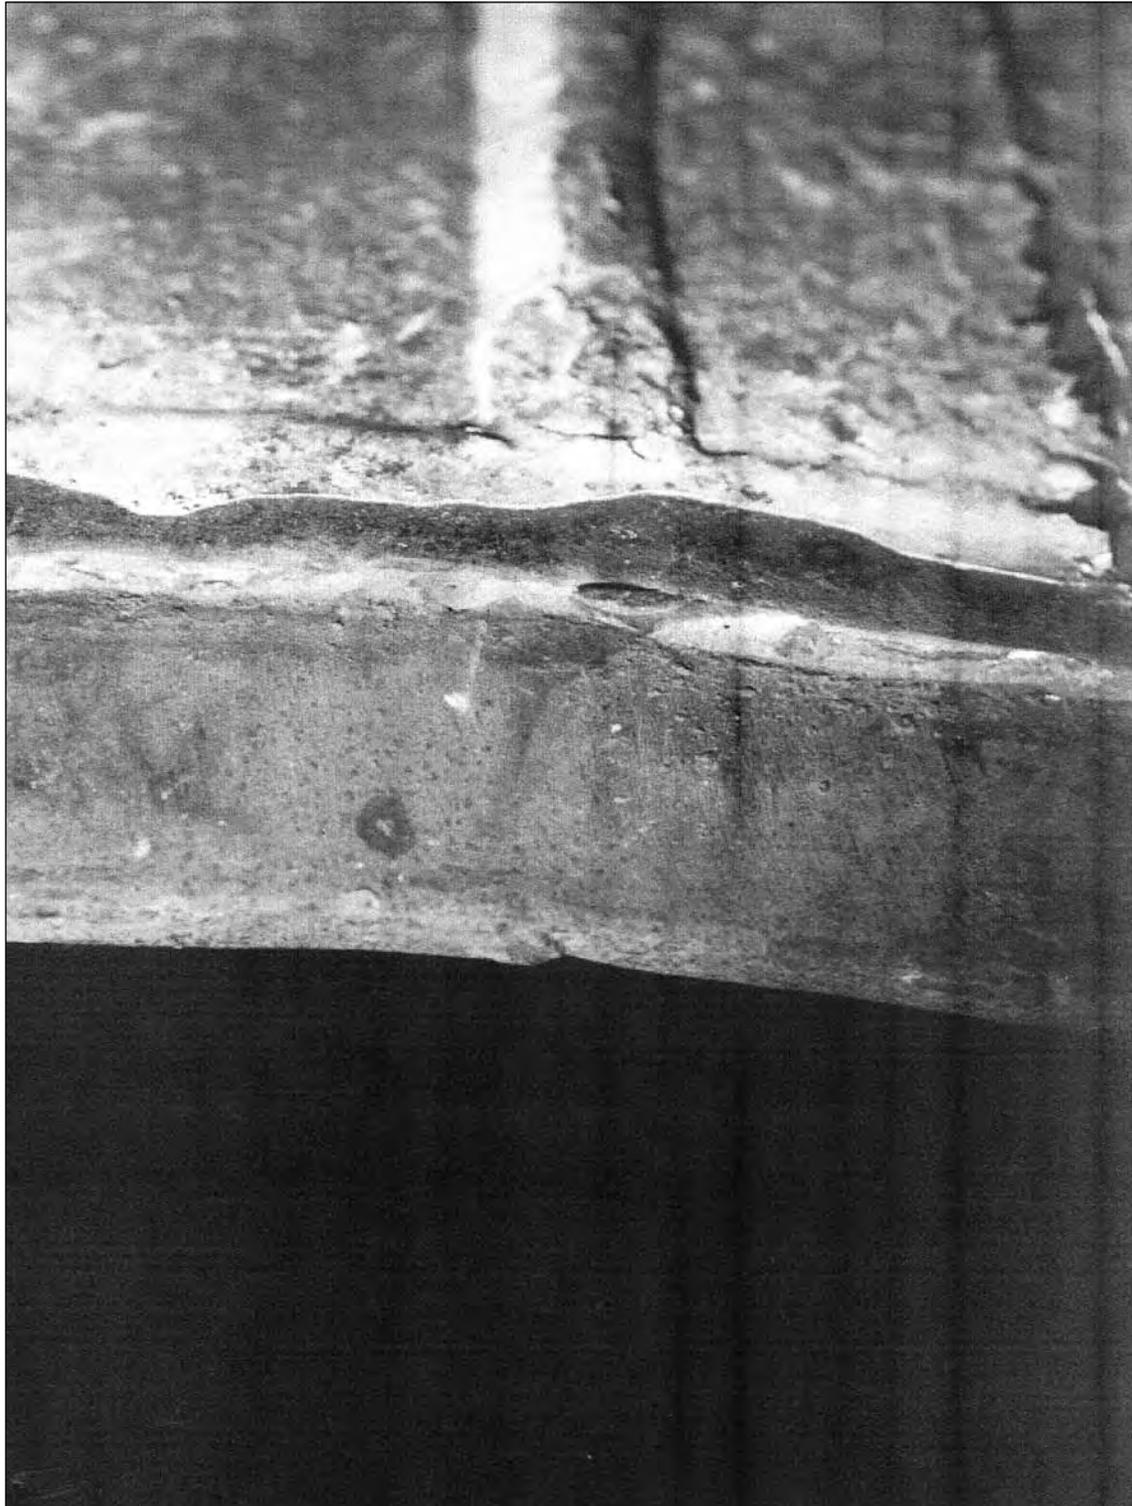
10. Close-up of a section of the rolled and welded seam between the cylinder section and the head.

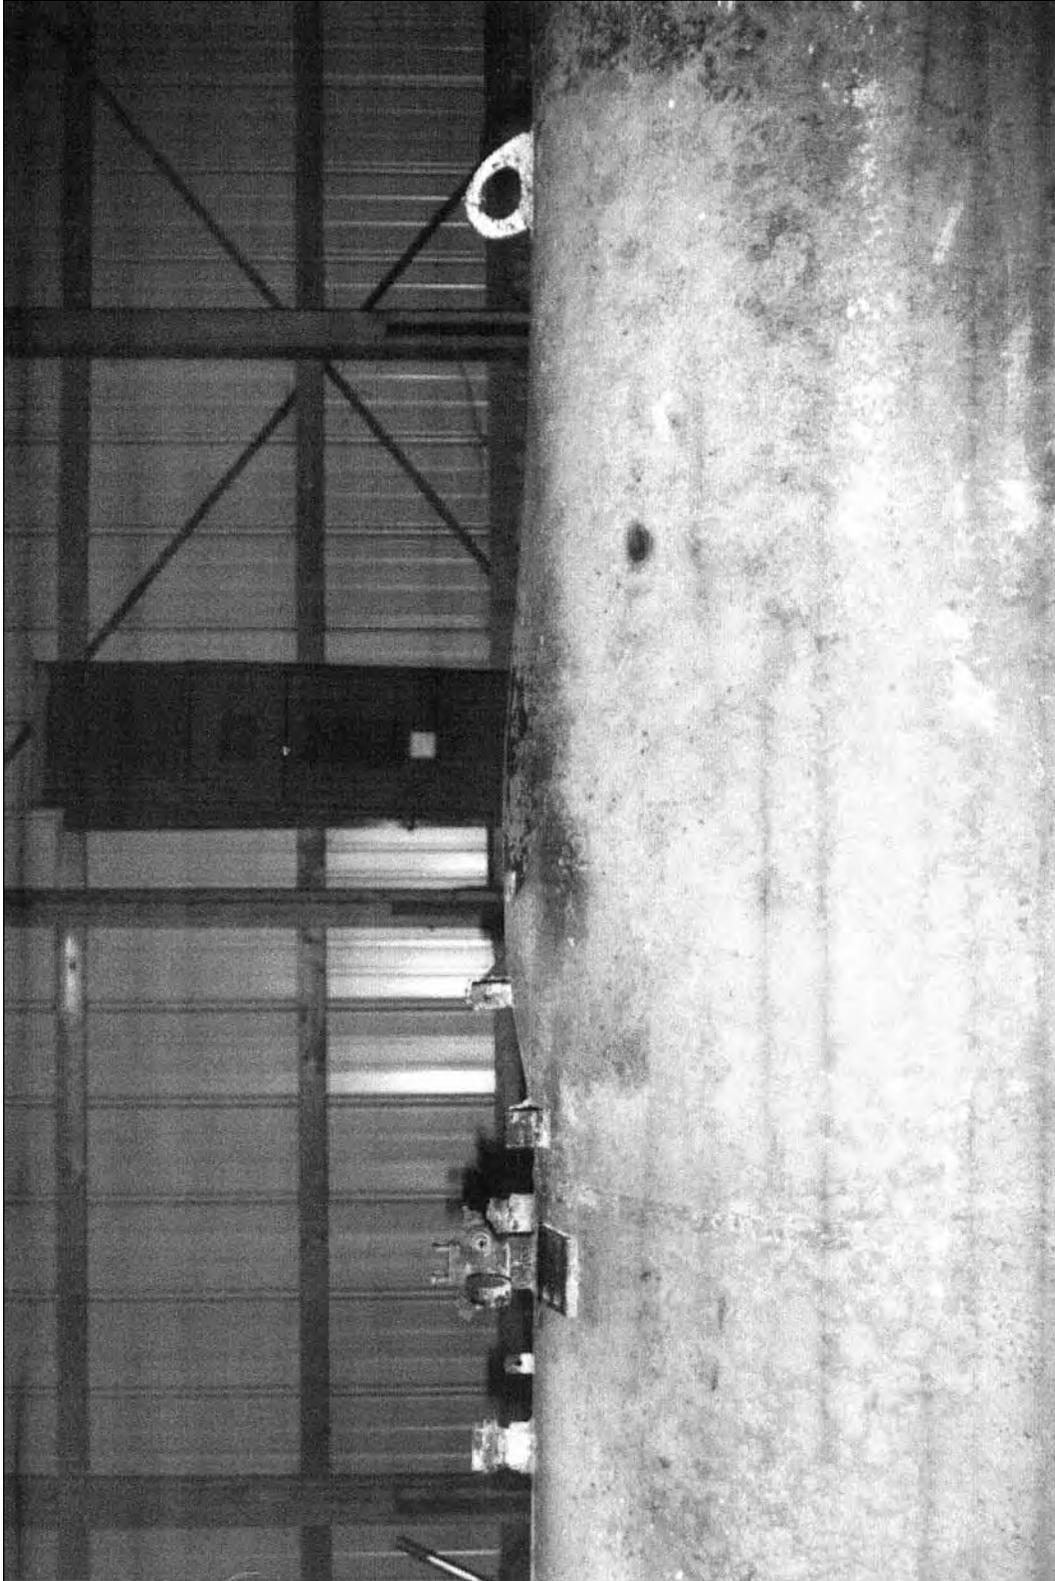
The west LP-Gas tank was also moved with a tank carrier to a secure storage location. At the time of the site visit, the original position and direction that the tank was facing prior to the incident had not been determined. It is hoped that the hinge connection for attachment of the protective valve cover may be used to determine which end of the tank faced north. (See Appendix F for photograph of the tank.) Around the hinge connection, a two to three inch high blister in the tank shell had formed over an area about 2 feet long by 1-1/2 feet wide roughly on top of the tank. The typical cause of tank metal deforming in this fashion is the direct flame impingement from burning LP-Gas on the tank shell in the vapor space. Allowed to continue, it is likely that this tank would have also BLEVE'd from the stretched and weakened metal.

11. Bulge in the metal on the top of the west LP-tank.

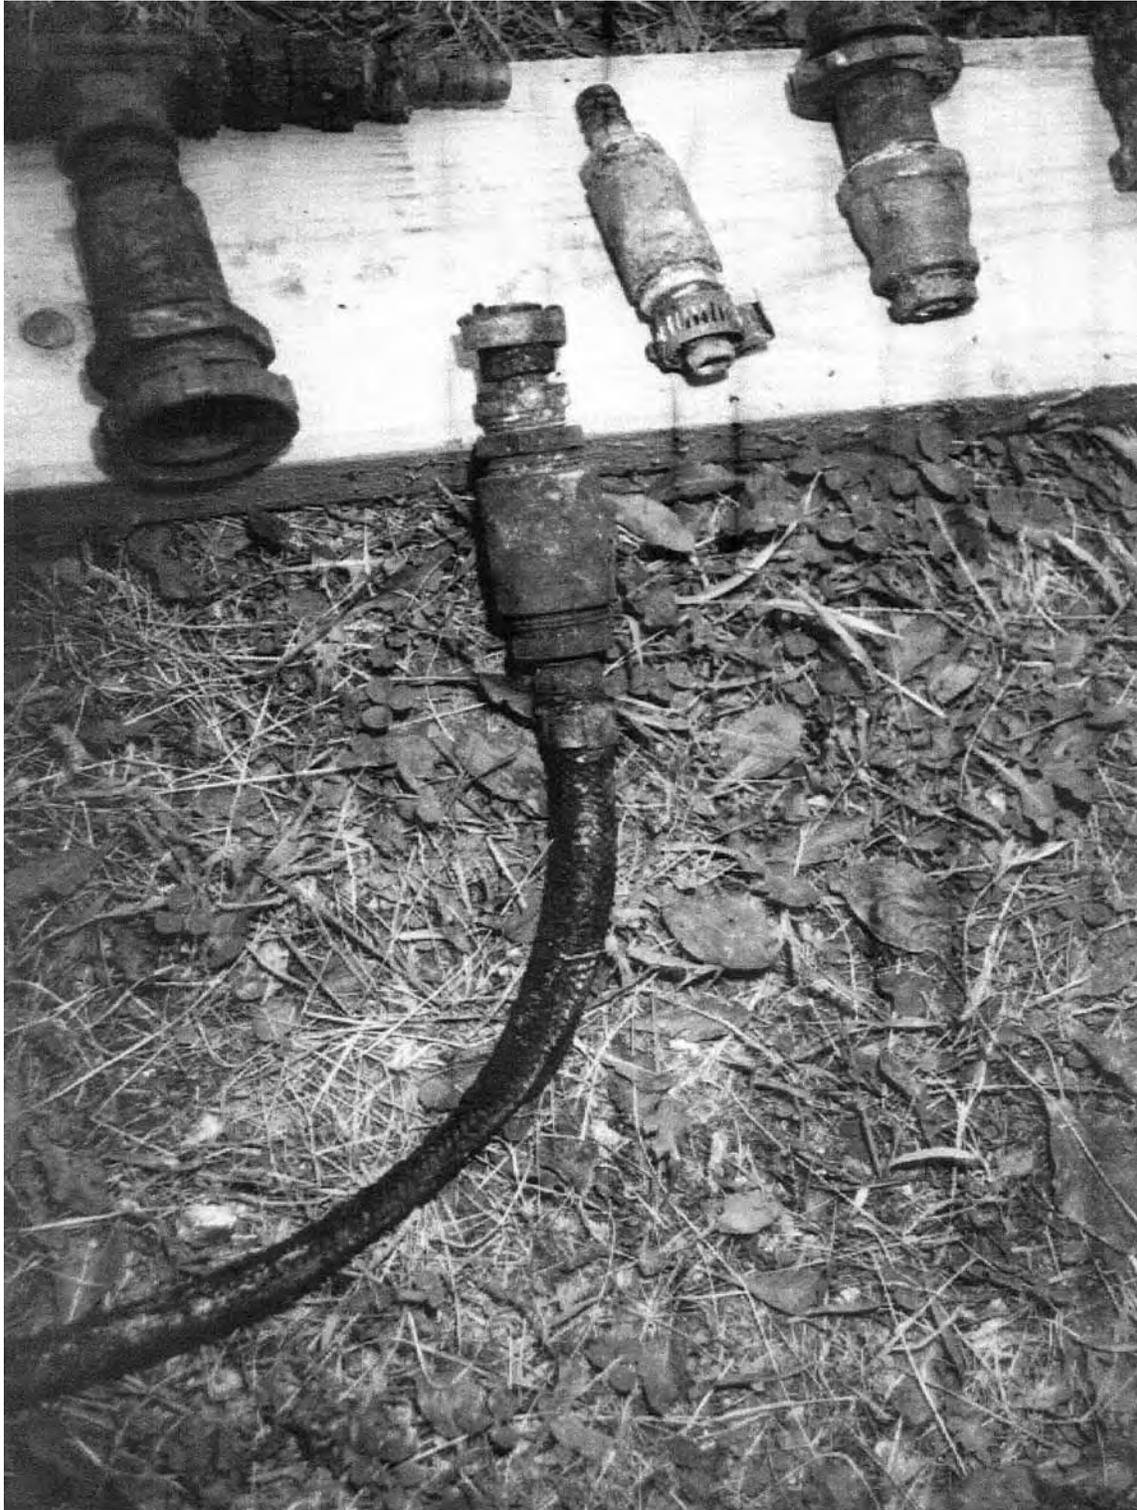
The remains of various LP-Gas hose connections were gathered after the fire. A number of the fittings used to attach the hose were not industry approved for use with LP-Gas hose. Substandard hose fittings included stainless steel bands with adjustable screws. It is suspected that these connections did not have sufficient pressure rating for the LP-Gas liquid service.

12. The LP-Gas hose fittings recovered after the incident.

NFPA Standard No. 58 limits flexible hoses to 36-inch maximum length. The LP-Gas supply hose from the tank to the dryer exceeded the maximum and should have been replaced with Schedule 80 pipe and high-pressure fittings. The heavy piping and fittings are needed because the line contains liquid LP-Gas and the operating pressure could exceed 250 psi. The piping between the tank and
